**Subject: Annual Inspection Report
Pine Hill Municipal Airport**

ANNUAL INSPECTION REPORT

PINE HILL MUNICIPAL AIRPORT

PINE HILL, ALABAMA

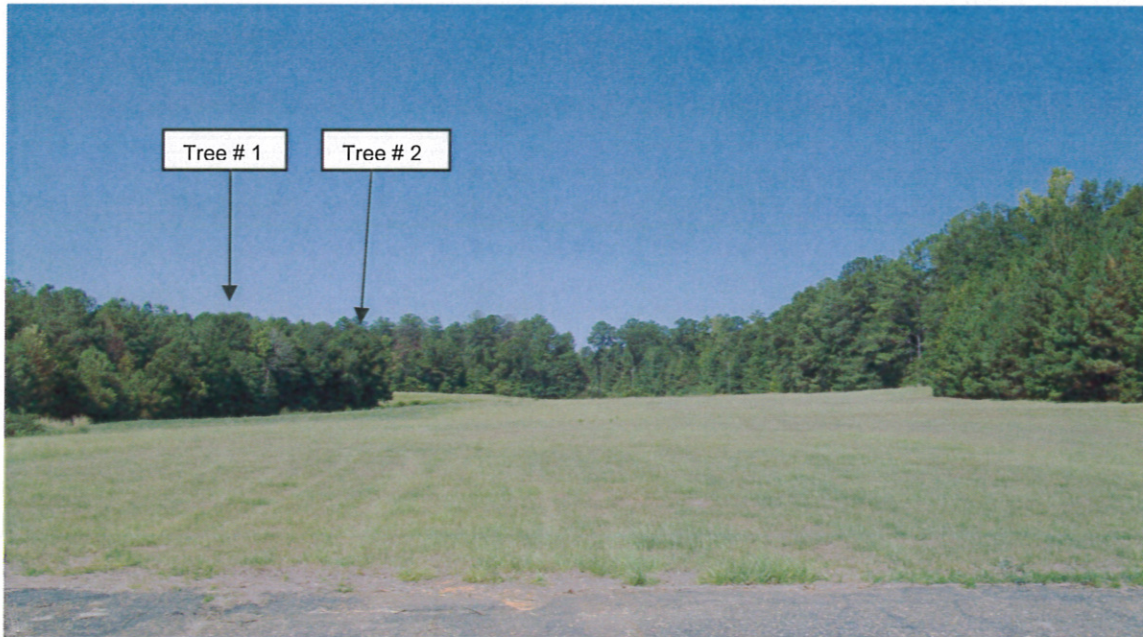
Photo # 1 – Rwy 9 Obstructions

- Runway 9: Trees identified as Tree # 1, and Tree # 2 violate the 20:1 approach/departure path (See Photo # 1 and Appendix 2).
- Runway 27: Trees identified as Tree # 5, Tree # 6, Tree # 7, Tree #8, Tree # 9, and Tree # 10 violate the 20:1 approach/departure path (See Photo # 2 and Appendix 3).

- While these are representative of obstructions in the approach departure path of runway 9/27 they are not all the obstructions that violate the 20:1 approach/departure path. All obstructions must be removed before an operating license may be issued.

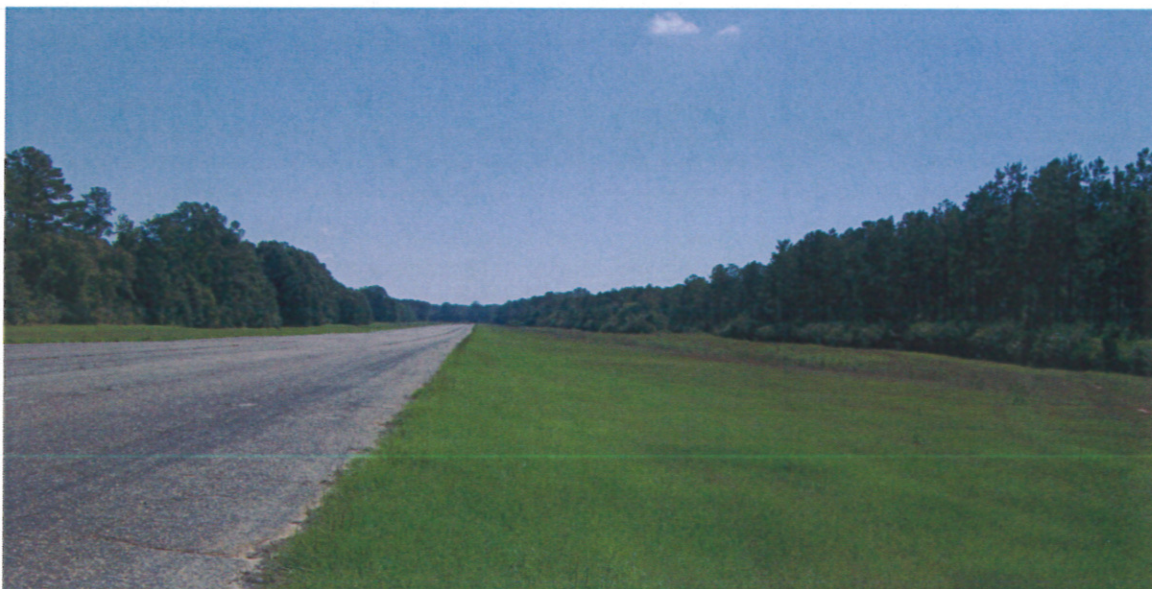
Photo # 3 – Primary Surface and Safety Area

- The primary surface meets state requirements (See Photo # 3).

- The runway safety area meets state requirements (See Photo # 3).

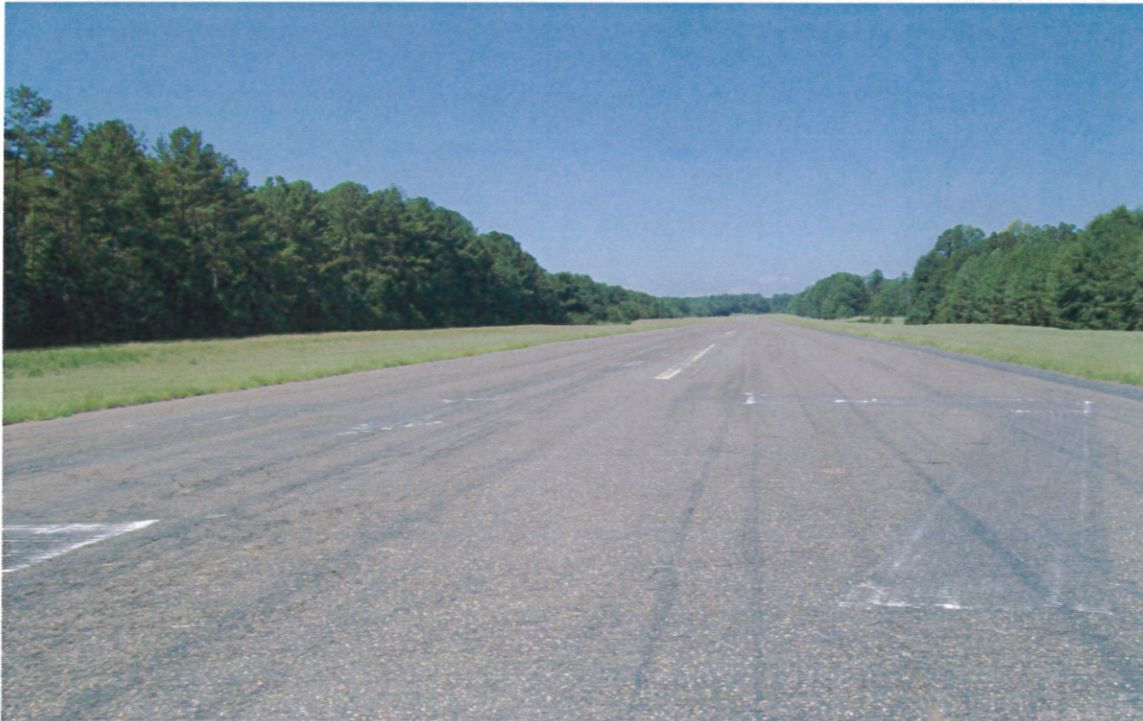
Photo # 4 – Runway Markings

- The runway markings are in poor condition due to fading (See Photo # 4).

- Markings should be replaced in accordance with FAA AC 150/5340-1J.

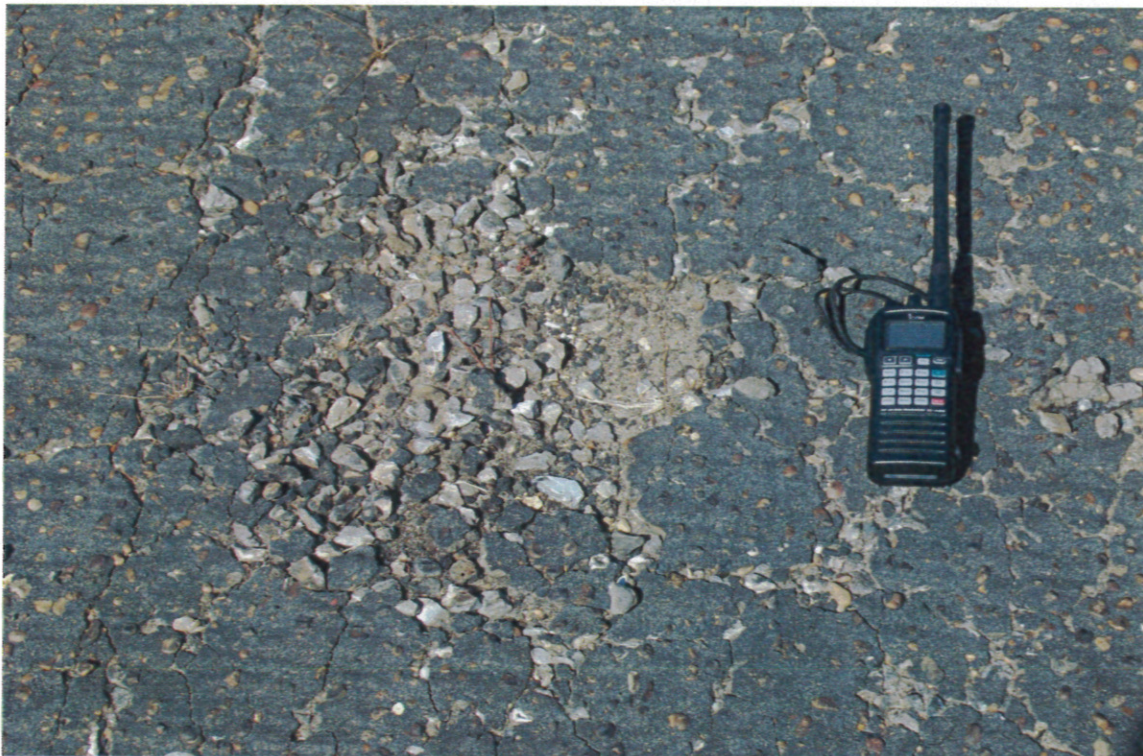
- The airport pavement surfaces are in poor condition, characterized by moderate to severe raveling, paving joint and edge cracks, alligator cracks with areas of failed pavement (See Photos # 5 - # 7).

Photo # 5 – Alligator Cracks with Debris

- Without major reconstruction the runway will soon become unusable.

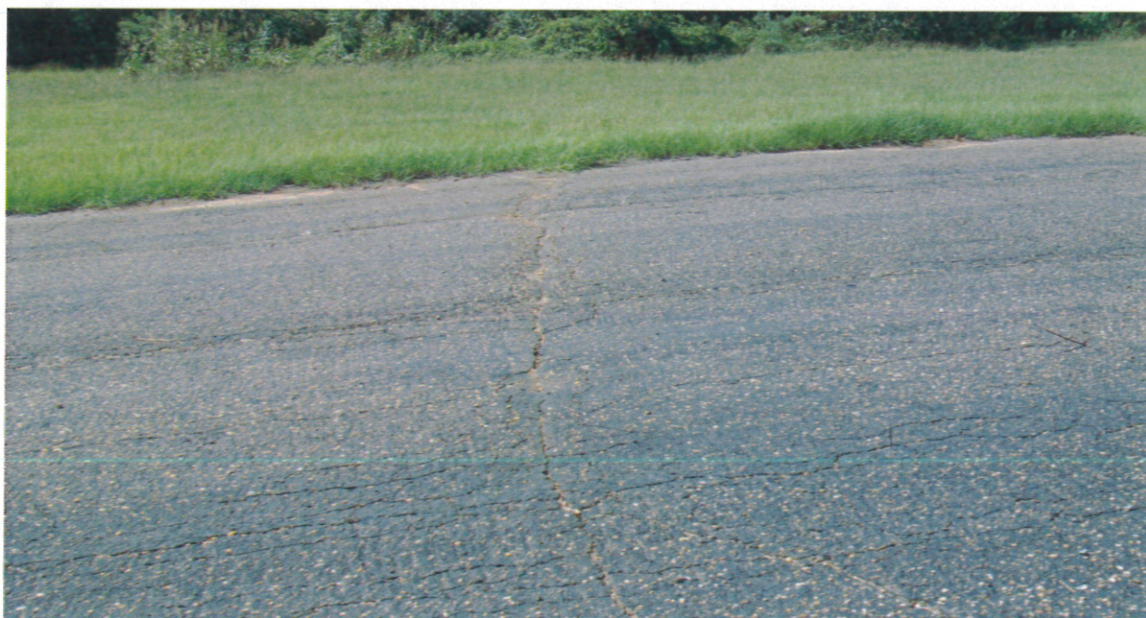
Photo # 6 – Edge Cracks

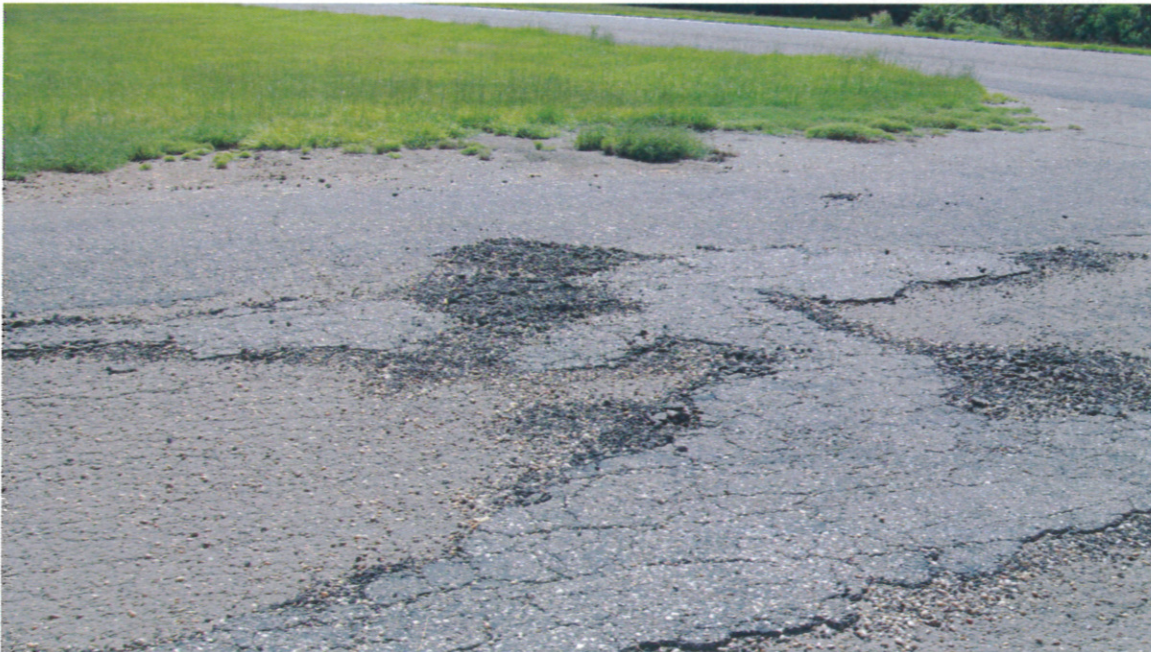
Photo # 7 – Failed Patches
